ARIZONA DEPARTMENT OF TRANSPORTATION

REPORT NUMBER: FHWA-AZ-8601

HILFIKER RETAINING WALLS WITH FULL HEIGHT CAST-IN- PLACE PANELS

Construction Report

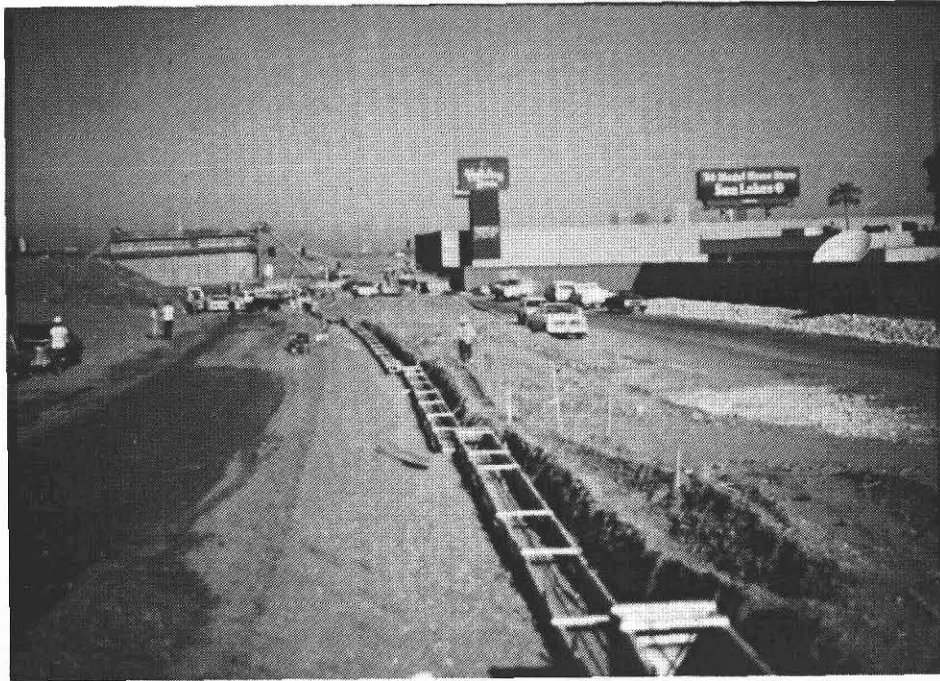
Figure No. 1 Preparation of the Subgrade and Levelling Course

A reinforced concrete leveling course of fifteen inches in width and six inches in depth was constructed as a base for the cast-in-place concrete face of the Hilfiker wall (Figure No. 1). The final grade of the subgrade was sloping 1% to 2% away from the face of the Wall.

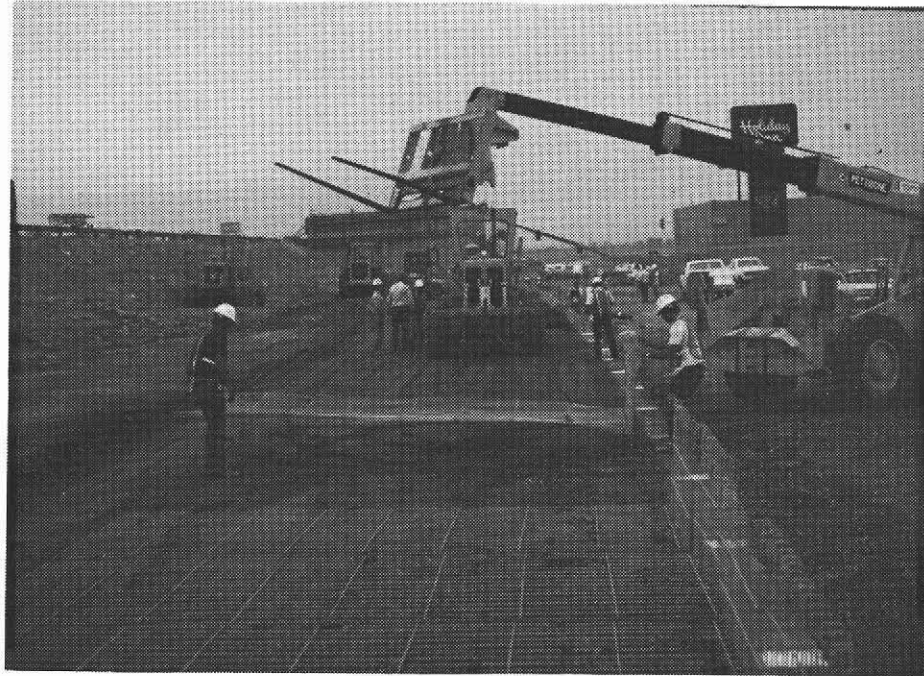
Figure No. 2 Placement of the First Layer of Reinforcements

The first layer of reinforcing mats was placed on the subgrade and pinned in place with form pins (Figure No.2). Mats were made of galvanized welded steel wire mesh (W7xW7). The reinforcing (horizontal) mats were 7.5'x20'(variable), while the backing mats were 8'x2'. Figure Nos. 3 and 4 show typical dimensions of the reinforcing mats and the backing mats respectively.

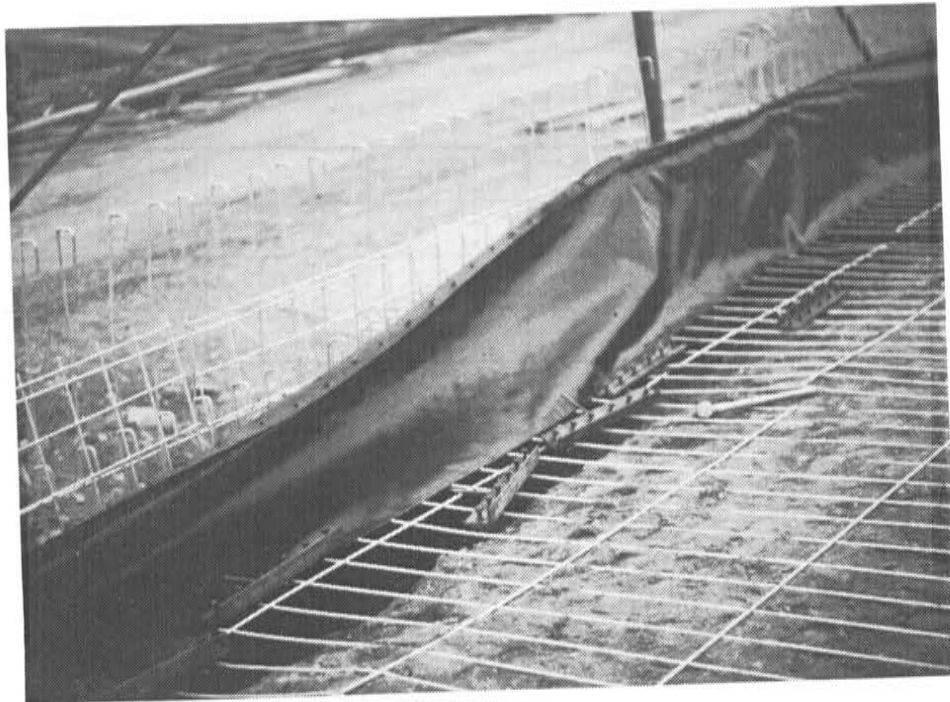
Figure No. 5 Tying of the Woven Geotextile Fabric Screen to the Reinforcements

Behind the construction mats a woven geotextile fabric screen was placed in order to retain the compacted backfill behind the wire mesh (Figure No.5). The fabric was initially rolled under the mats but that left a 1/2" to 3/4" crevice which caused concern that the concrete might not fill the crevice. The fabric was then cut at 1/2 ft. intervals and placed in the vertical face of the mats.

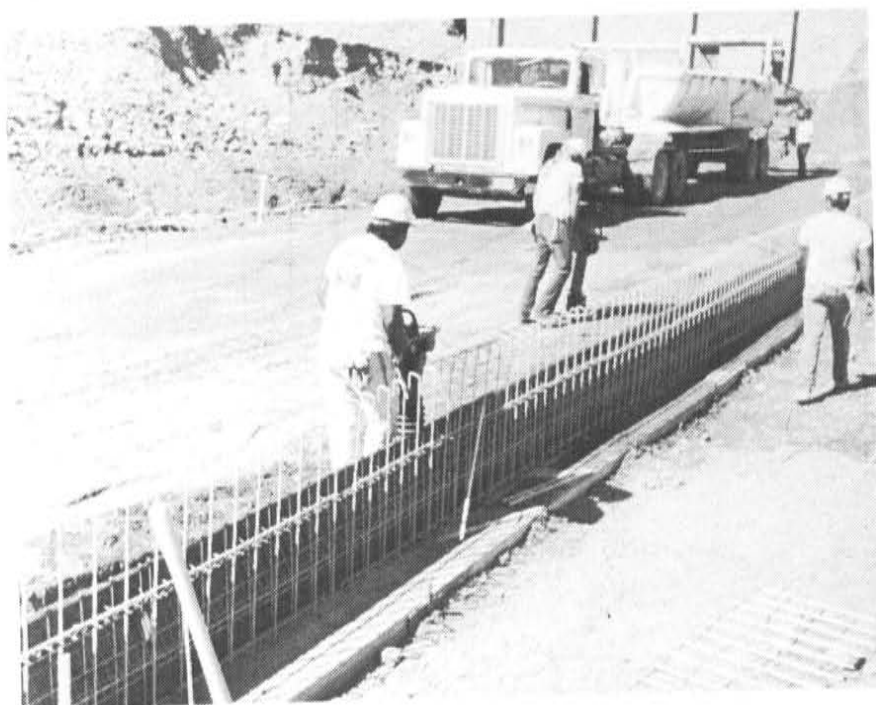
Figure No. 6 Trucks Dumping the Backfill Material and Workers are Compacting the 2 Foot Zone Area

Compaction within 2 ft. nearest to the backing mats (2 foot zone) was performed by water jetting the 1 ft. closest to the backing mat, while the second foot was mechanically compacted by a hand vibrating tamper (jumping jack). Initially hand rammers were used but were found to be slow and inefficient. (Figure No. 6 shows the trucks used for dumping backfill material and the tampers used to compact the AB material in the 2 foot zone).

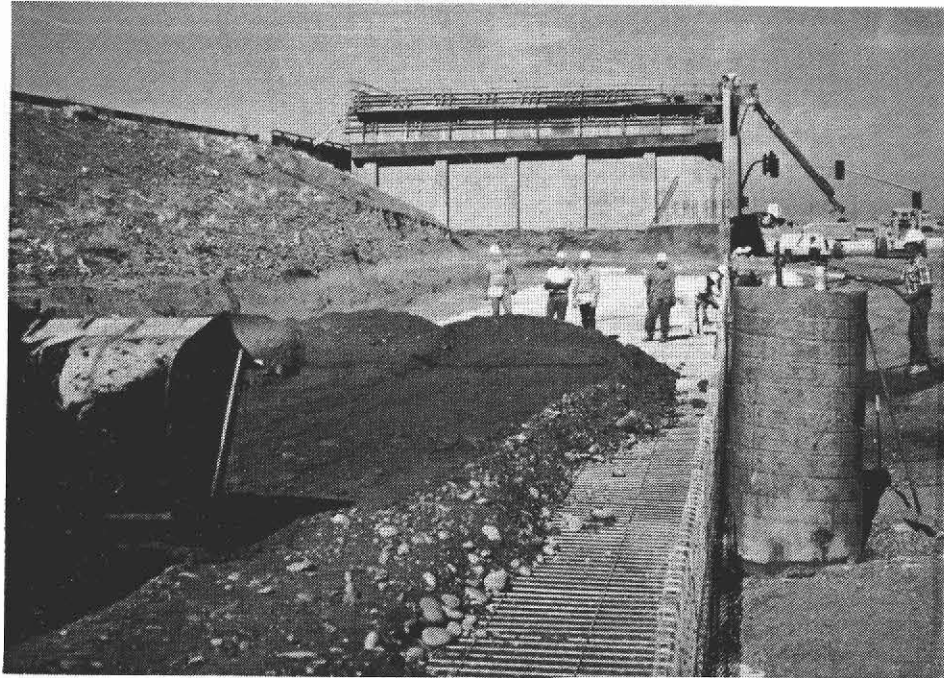
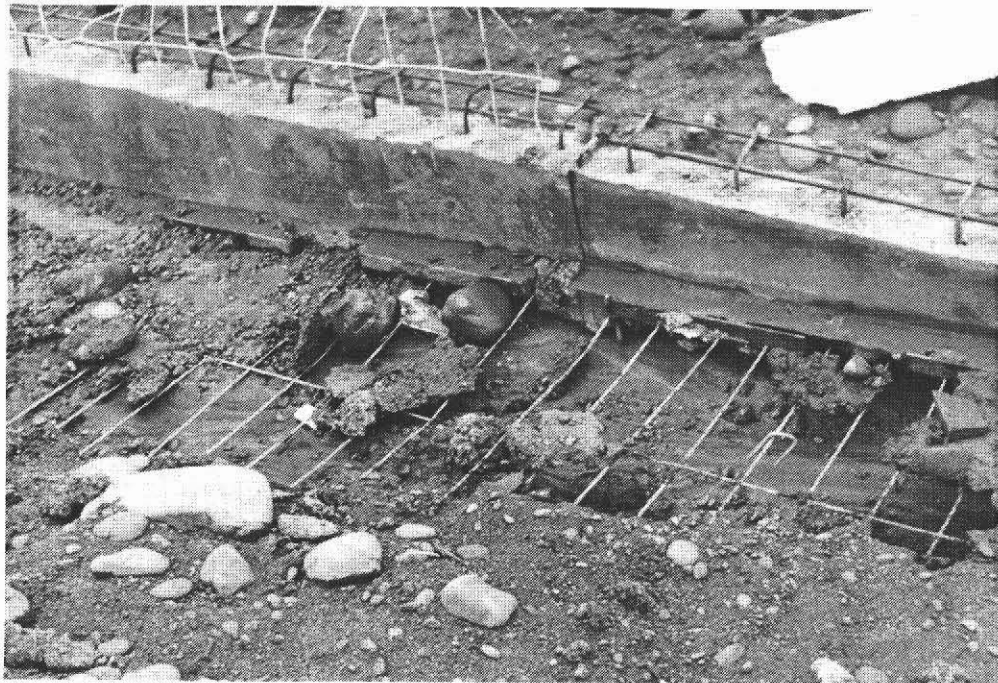
No special requirements were specified for the backfill material in the 2 ft. zone. However, attempts were made by the contractor to use backfill material that passed a 4" sieve size during the

construction of the N.E. and the S.W. walls. Such attempts, as witnessed by the author, did not always prove to be successful as can be seen in Figure No. 7.

Figure No. 7 Backfill Material Used With Unsuccessful Attempts to Dispose of Rocks Larger Than 6" Sieve Size (Different Locations).

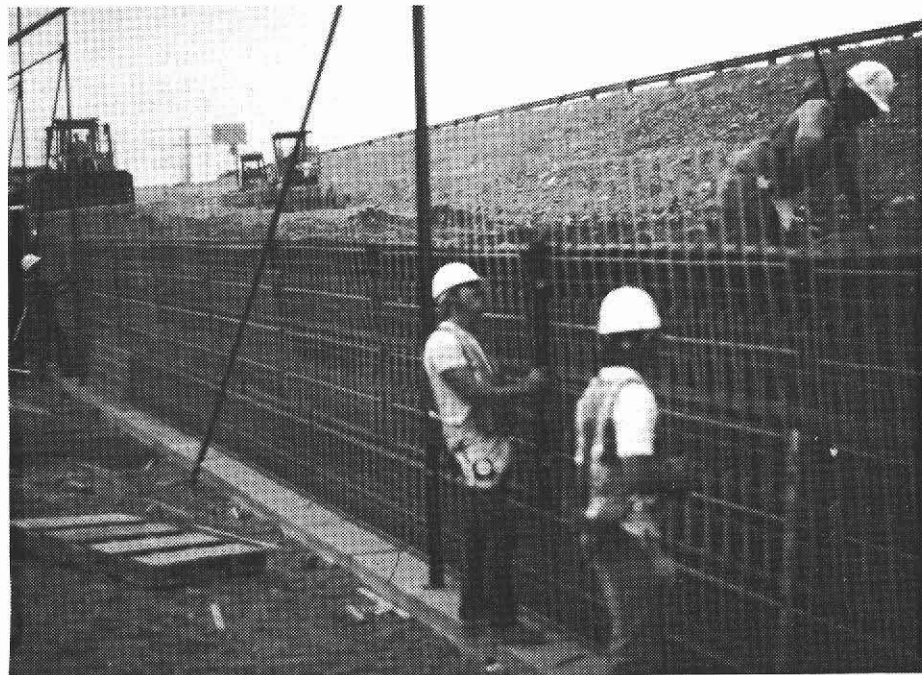
Figure No. 9 Workers Checking the Vertical and the Horizontal Alignment of the Hilfiker Wall

The contractor checked the outside vertical and horizontal alignments of the reinforcements by using a four foot carpenter's level and string line. With the addition of vertical layers of reinforcing mats the new mats lock into the proceeding ones. This locking effect ensured the verticality as the height of the wall increased (Figure No.9).
